## Inspection Report Minerals Regulatory Program Report Date: November 15, 2004

**Mine Name:** Clark #1/Emeryide

**Permit number:** S/015/053

**Inspection Date:** November 5, 2004

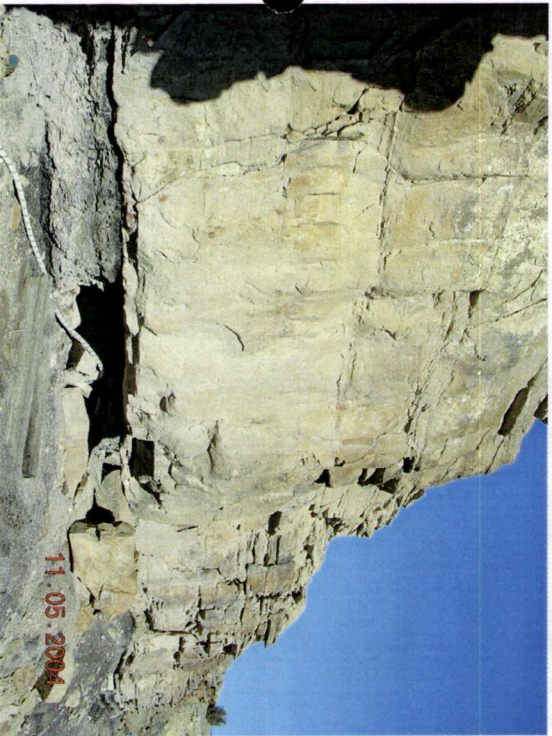
There are a few rocks that have some potential of falling, but we focused on one specific rock shown in Photos 1 through 3. Photo 3 shows how this rock has separated from surrounding bedrock. To find this rock, go down to the pad level from the south and continue to follow the pad until it ends. Just after the pad ends, one can see the undermined area shown in Photo 1. This rock is the one we determined has the most potential of falling.

After seeing this rock, how it sits in relation to the pad, and what other rocks have fallen toward the road. Mr. Tetrault felt that, although the rock is not very stable in its current state, there is little chance of it falling and rolling all the way to the road. He believes the rock will likely settle in place without falling at all, but even if it does rotate and start down the hill, it is large enough and angular enough that it is unlikely to get to the road. I think it would rotate and fall rather than settling, but it is hard to say whether it would go all the way to the road.

**Photo 1. A sandstone block that has been undermined and appears to be unstable.**

1. Some of the sandstone could be forced to fall to clean up the face. Mr. Tetrault indicated there are firms that perform this sort of work for reasonable costs. If this is done, the road would need to be temporarily closed. This will not be required unless the operator decides to conduct further mining.
2. Until the face has been cleaned up, mining will not be allowed in the areas above the Miller Canyon Road. There are some mining areas that are not above the Miller Canyon Road, but I am not sure whether they are within Bob Clark's permit area.
3. The operator would be allowed to take any previously-mined material in the stockpile.

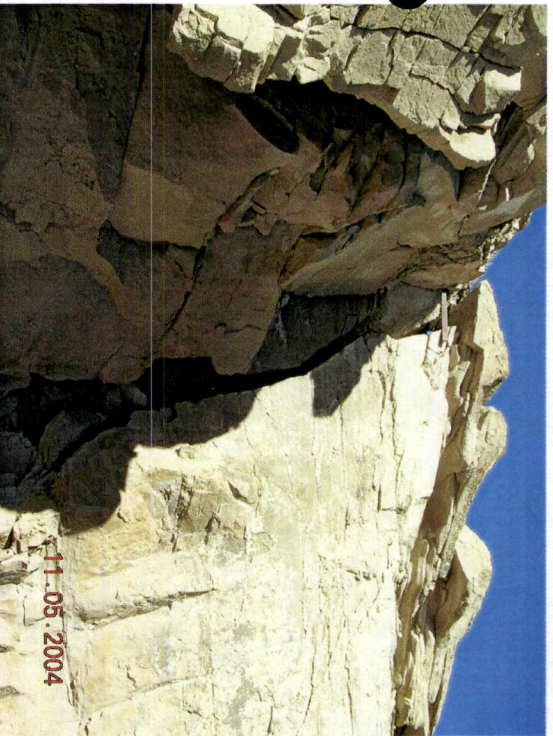
**Photo 2. Crack along the side of the block shown in Photo 1.**

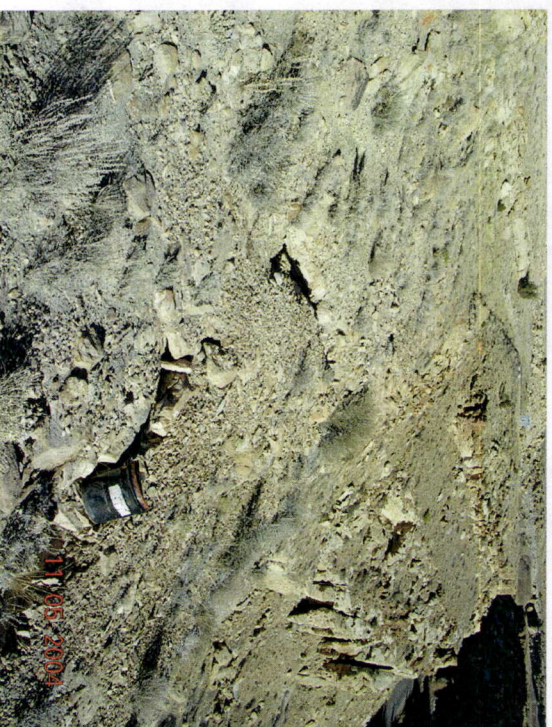
**Photo 3. The top of the block shown in Photo 1.**

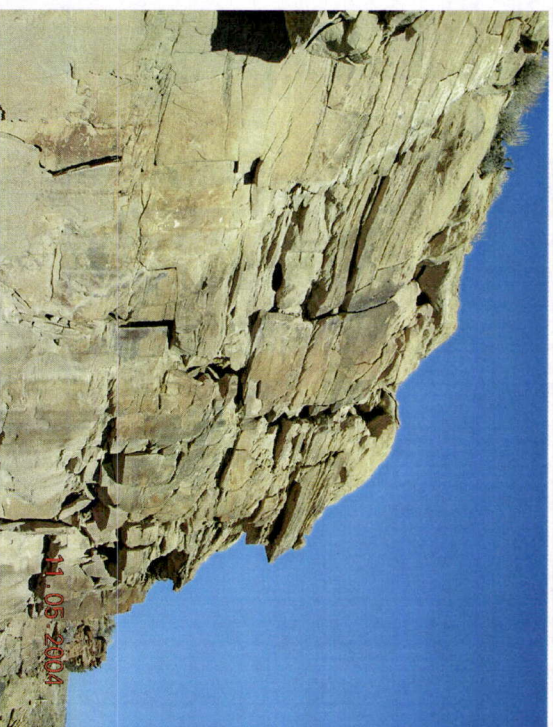
Although the site has portals for underground mining, it appears there has, in the past, been some surface mining under some of the sandstone blocks. Some of the blocks have settled, including one right next to the one discussed above, and a few have fallen. It also appears underground mining may have destabilized some of the rocks. Photo 4 was taken looking toward the north from near the north end of the southernmost pad, and it shows several rocks that have broken away from the adjacent sandstone bedrock but have not yet fallen.

**Photo 4. Some rocks in a nearby area that have separated from the adjacent bedrock.**
